**FINAL REPORT**

**Demonstration of ECDA Applicability and  
Reliability for Demanding Situations**

**DOT Prj#195**

Gas Technology Institute

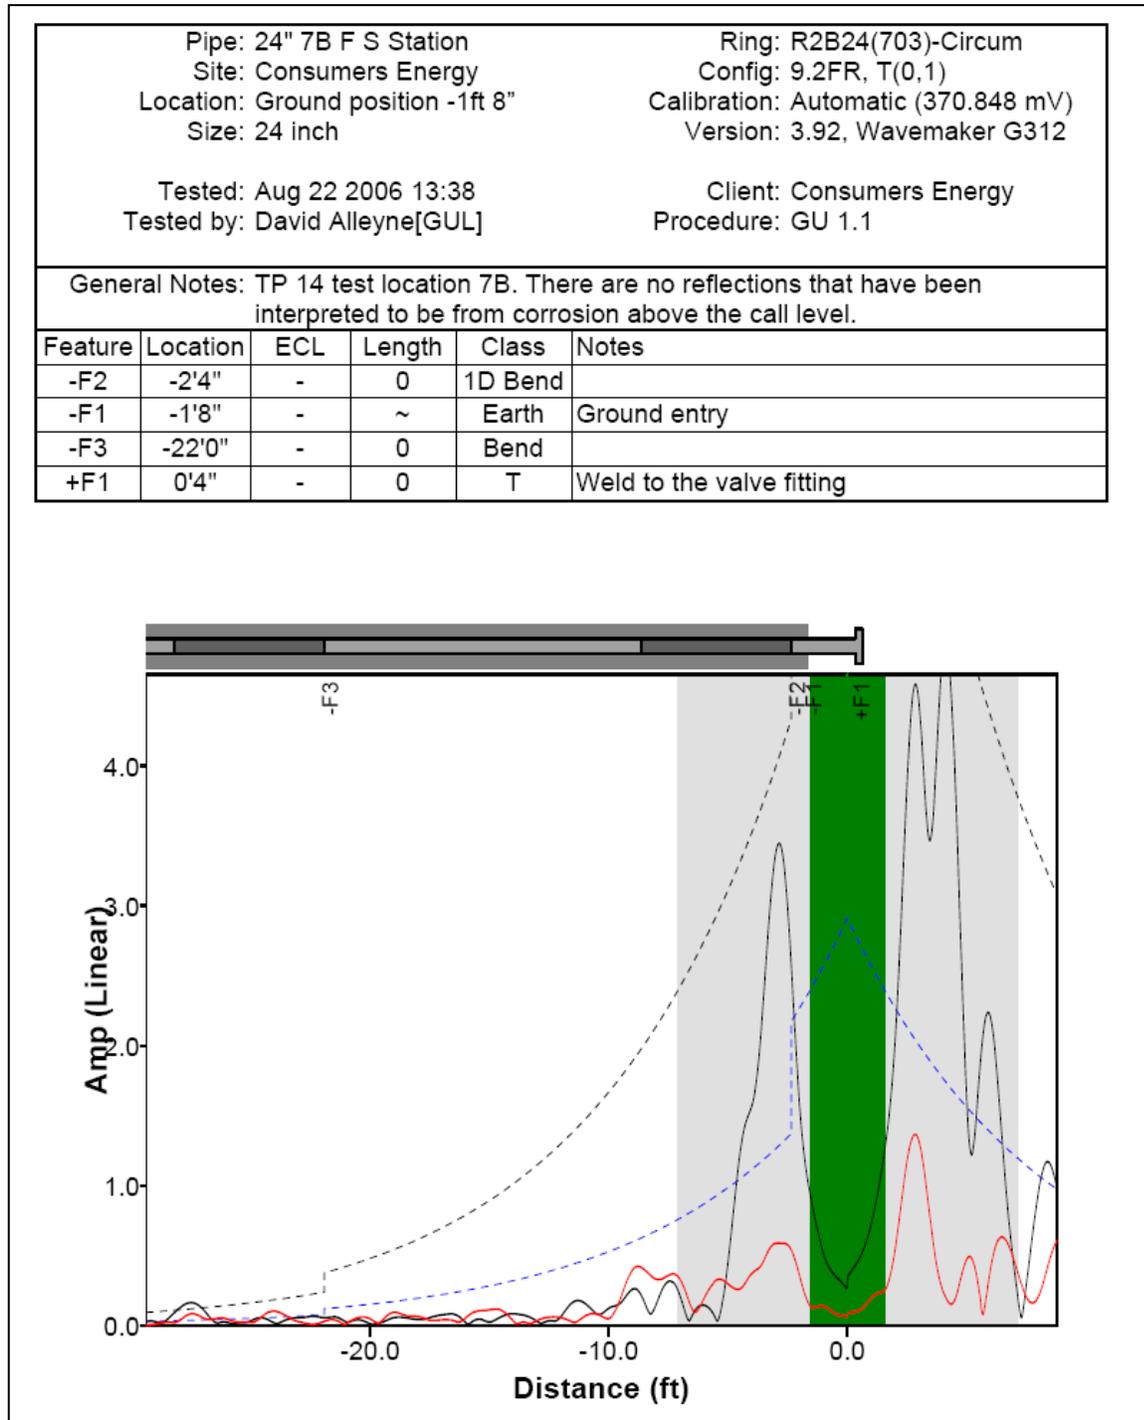
Figure 64. Dig Site 7B - PE.

Test location 7B. There are no reflections that have been interpreted to be from corrosion above the call level.

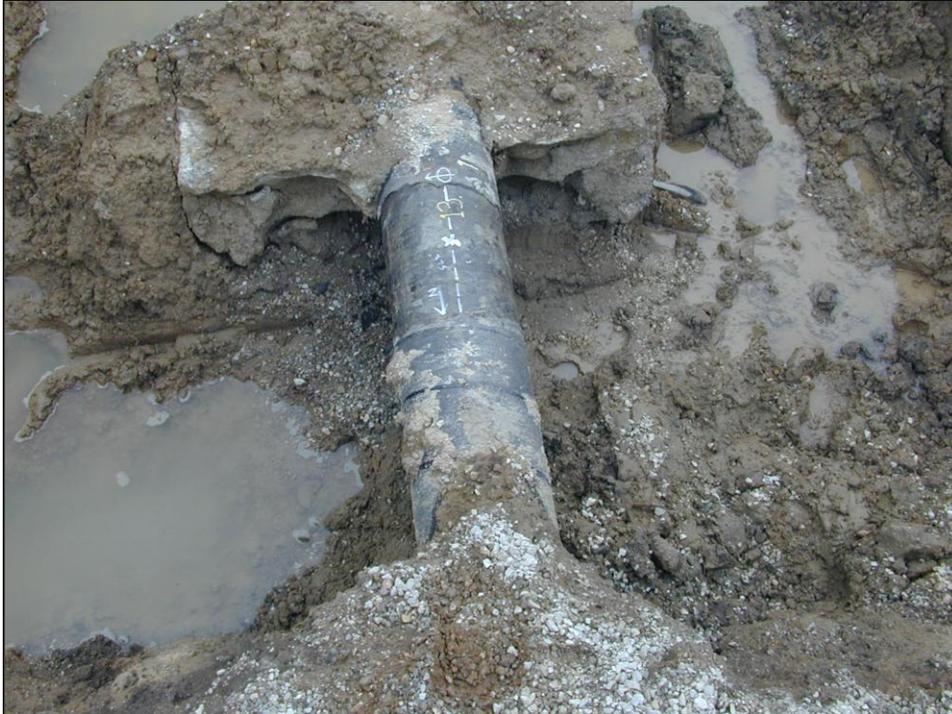
**Figure 78. Areas 9A and 9B.**

A single RT image at the 06:00 position was produced for pipe at Areas 9A (yellow arrow) and 9B (green arrow) on both sides of the tee. No density changes consistent with the presence of localized corrosion were visible. View is looking southwest.

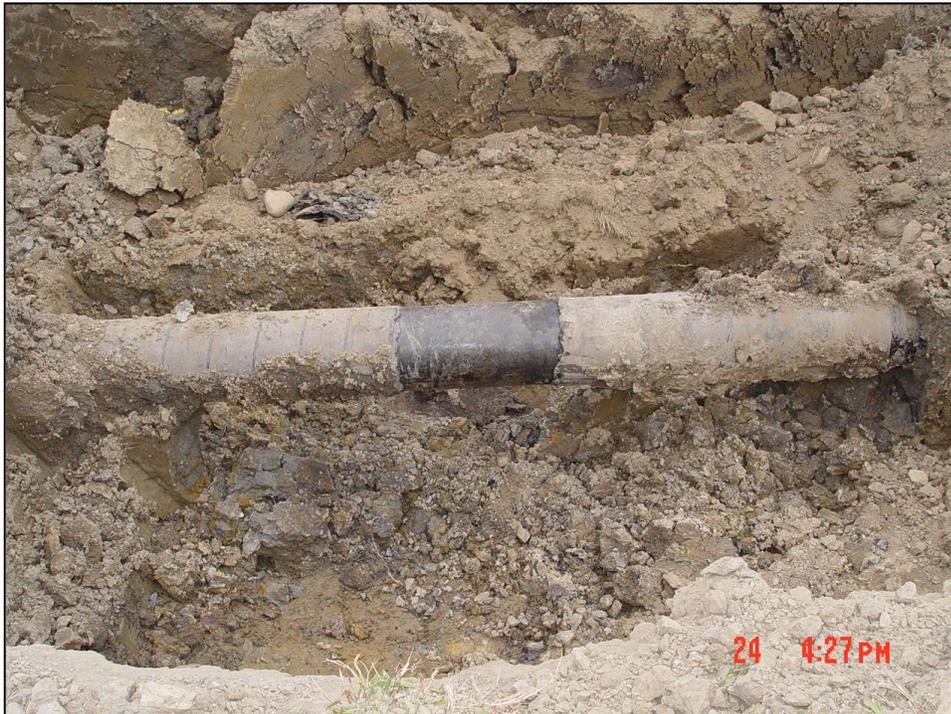
**Figure 85. Area 10.**

A single RT image at the 06:00 position was produced. No density changes consistent with the presence of localized corrosion were visible. View is looking to the east.

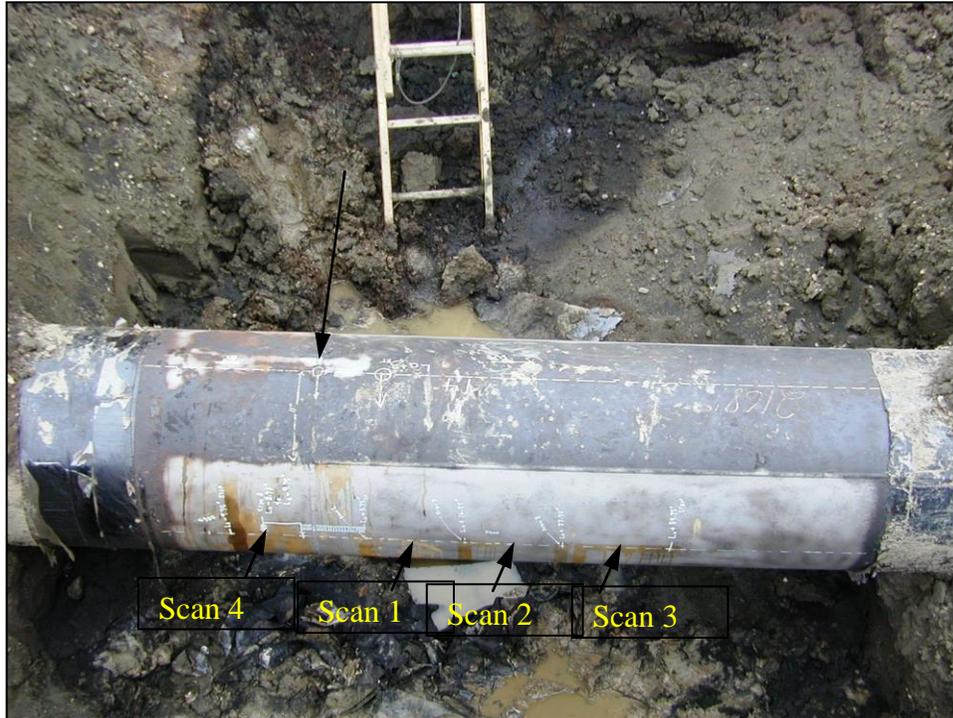
**Figure 87. Dig Site #14.**

Density changes in the pipe bottom consistent with localized corrosion were present on the radiographs at the pipe bottom. Ultrasonic testing (Porta-Scans) of the pipe bottom was initiated. The figure above shows the locations of the four pipe scans in relation to the girthweld (green arrow). The locations of the scans are shown with the arrows pointing at a dashed line drawn at the 3:00 o'clock position. The pipe was scanned at the 5:30 to 6:30 positions. View is looking south.

Dig Site #14 - Visual Inspection showed no external corrosion with coal tar coating in good condition. Pipe was 26" diameter, 0.375" wall, X-60, 1982.

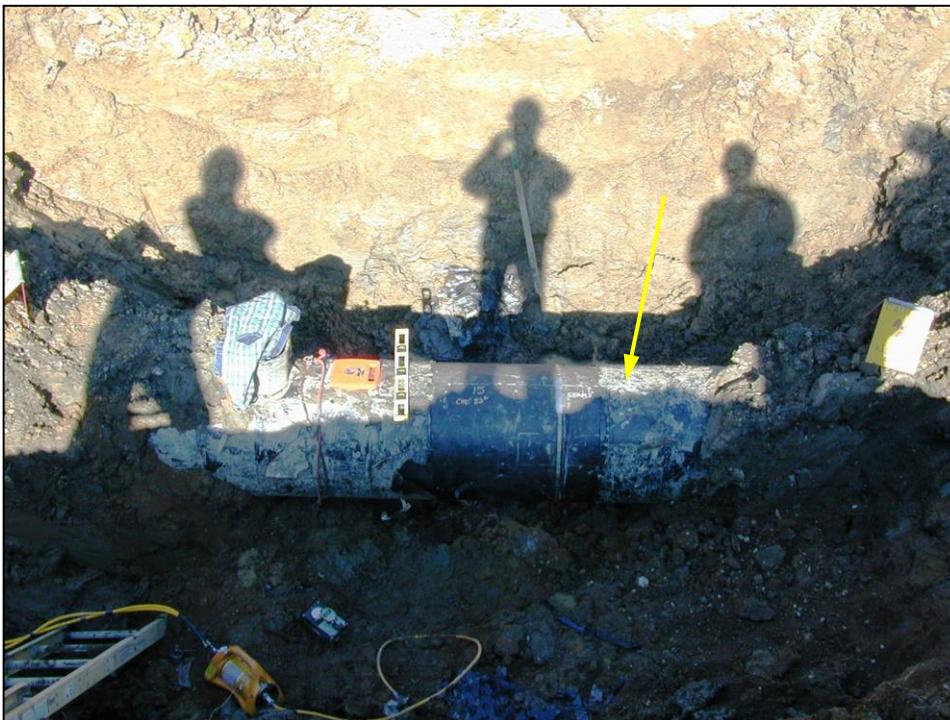
**Figure 92. Dig Site #15.**

The Lo is shown by the yellow arrow. A girthweld is located 12 inches east of the Lo position. Radiographs determined the presence of sludge at a level from the 4:30 to the 6:45 position at the pipe ID. Long seams were found at the 9:30 region west of the girthweld and at the 12:30 position east of the girthweld.

Minor Density changes in the pipe bottom consistent with localized corrosion were present on the radiographs. Ultrasonic inspection was conducted manually on those three areas: at the

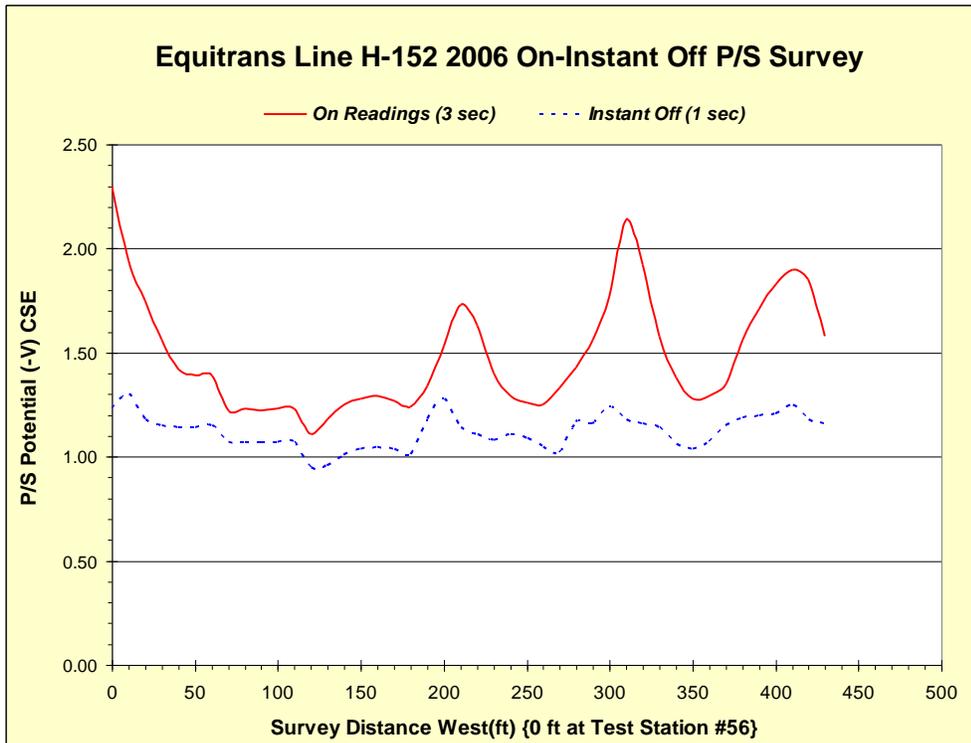
Figure 97. On-Instant Off P/S Survey.

- In 2006 Equitrans performed (plots are below):
  - > CIS on/instant off potential surveys
  - > Depolarized (native) potential surveys (w/time)
  - > Side drain ("hot spot") potential surveys after the line was at the native potential.

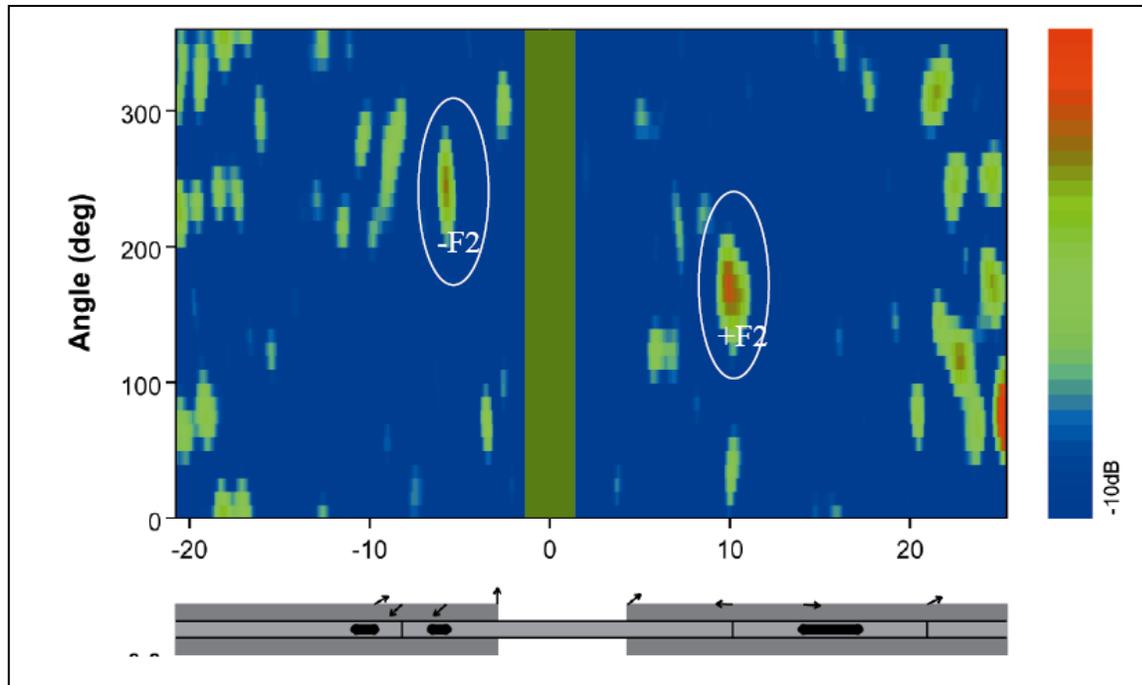
**Figure 104. Pulse-Echo C- Scan of Dig Site #0.**

The unrolled pipe display (C-Scan) shown in the figure above, highlights some areas of interest that were confirmed by radiographic inspection of the 1952 welds were considered to be sub-quality by today's (modern) standards. The following defects were reported (inadequate penetration, burn through, slag inclusions and lines, external undercut, porosity, gas pockets, and concave crowns). These areas, which show a more concentrated cross section change include:

- (-F2) The area 5 ft to the east of the ring, on the north side (about 250 degrees) was below call out level and due to mineral deposits, no corrosion was found during direct exam.
- (-F3) Assumed weld was confirmed upon excavation.
- (-F4) Assumed feature due to deposit (not corrosion) confirmed.

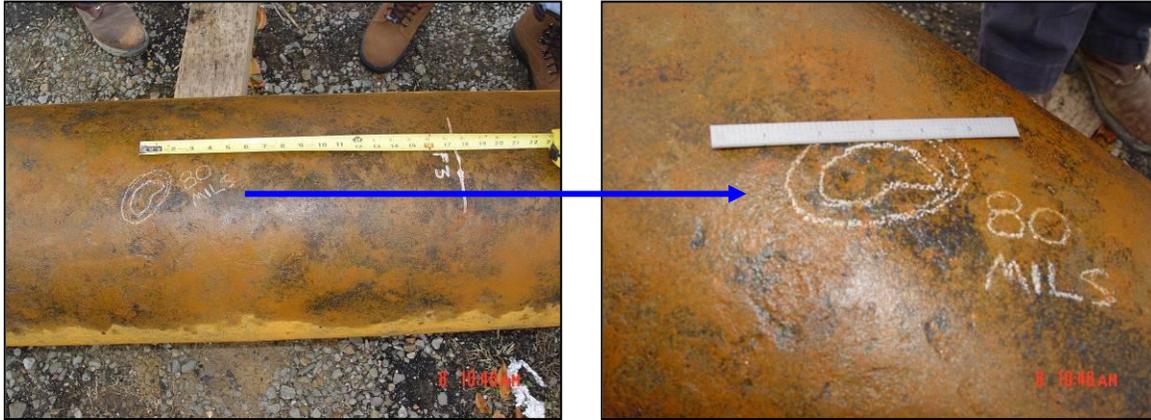
- (+F2) The marked weld 10 feet to the west of the ring, which shows a stronger reflection from the bottom of the pipe than the top.
- (+F3) Called out as a Cat 3 feature, confirmed as 1" long, 80 mil deep pit cluster 17" west of the +F3 start position. Feature on pipe lines up with maximum ECL peak with lack of symmetry.

Figure 106. Pictures of feature (80 mil deep pit cluster, 1 inch long) that lined up with the maximum non-symmetric second peak for +F3.

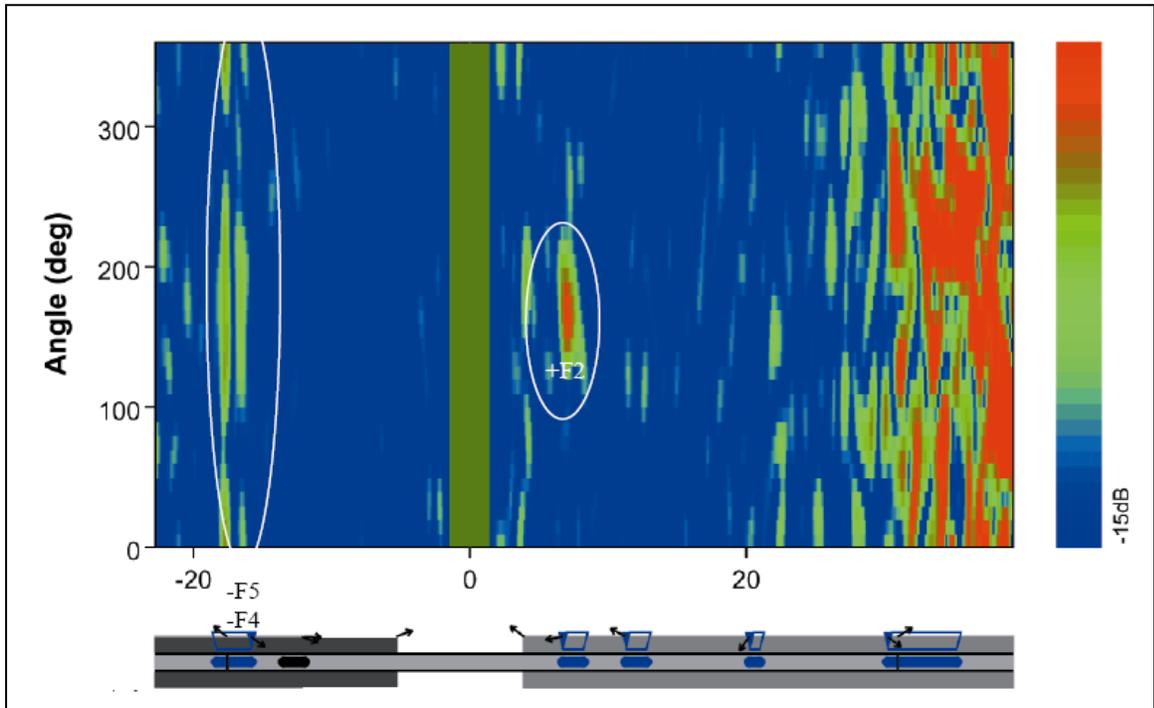
Figure 110. Pulse-Echo C- Scan of Dig Site #1.

- (+F2) Cat 2 strong reflection along bottom of pipe was confirmed as leafing corrosion along the bottom of pipe that extended into the earth to the West (all along the 6 o'clock position), see picture below.

- (+F3) Cat 1 possible deposits. No corrosion was found only deposits before cleaning.

- (-F4 & -F5) Called out as a weld with possible mitre bend/joint. Confirmed as marginal weld with the following defects (inadequate penetration, burn through, slag inclusions and lines, external undercut, porosity, gas pockets, and concave crowns).

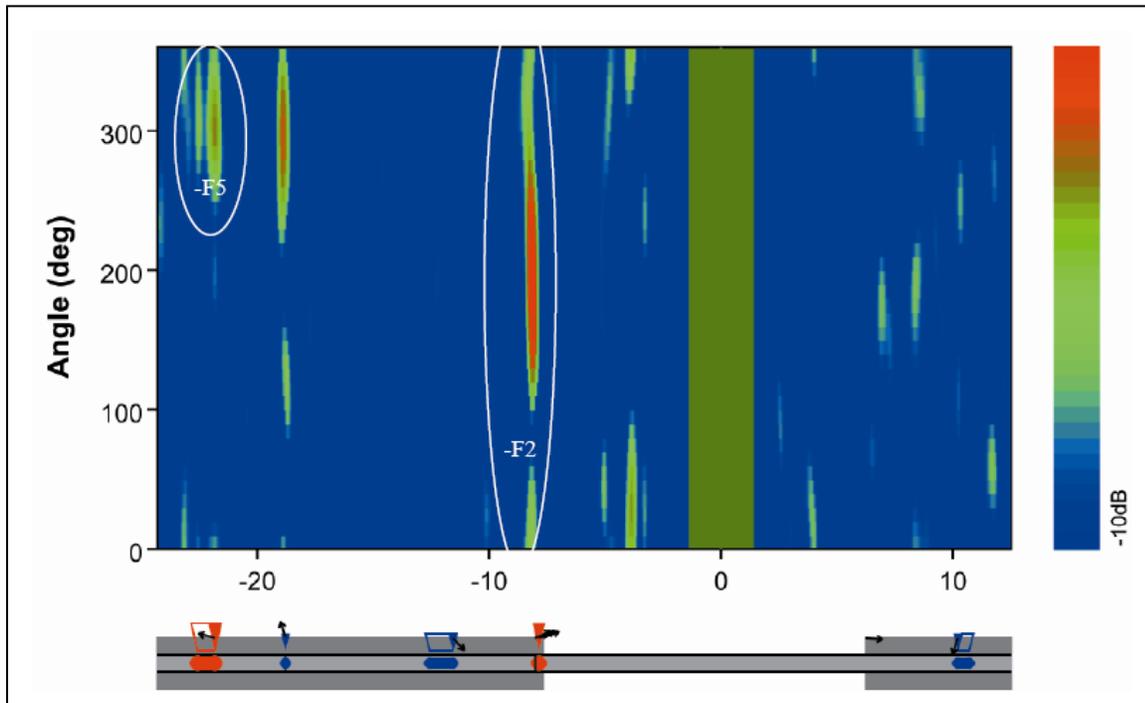
**Figure 117. The unwrapped pipe result of G308#3335 (from bell hole 2), showing the circumferential concentration of the feature at -22 feet (-F5) and the ‘missing’ part of the reflection from the suspicious weld at -8 feet (-F2).**

- (+F2) & (+F3) were called out as minor Cat 3 indications. This entire pipe joint had minor pitting (~20 mils) over most of the surface.
- (-F2) & (-F4) welds were called out as highly suspicious and were confirmed as marginal welds with the following defects (inadequate penetration, burn through, slag inclusions and lines, external undercut, porosity, gas pockets, and concave crowns).
- (-F3) & (-F6) Were called out as Cat 2 and Cat 1 features respectively. Both areas had no significant corrosion and were probably due to the mineral deposits.

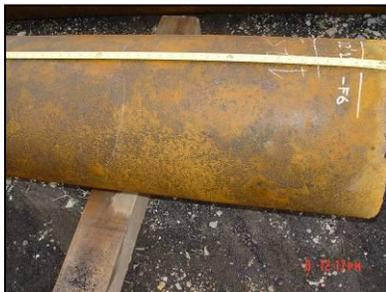
**Figure 118. Dig site #2 showing location -F6.**

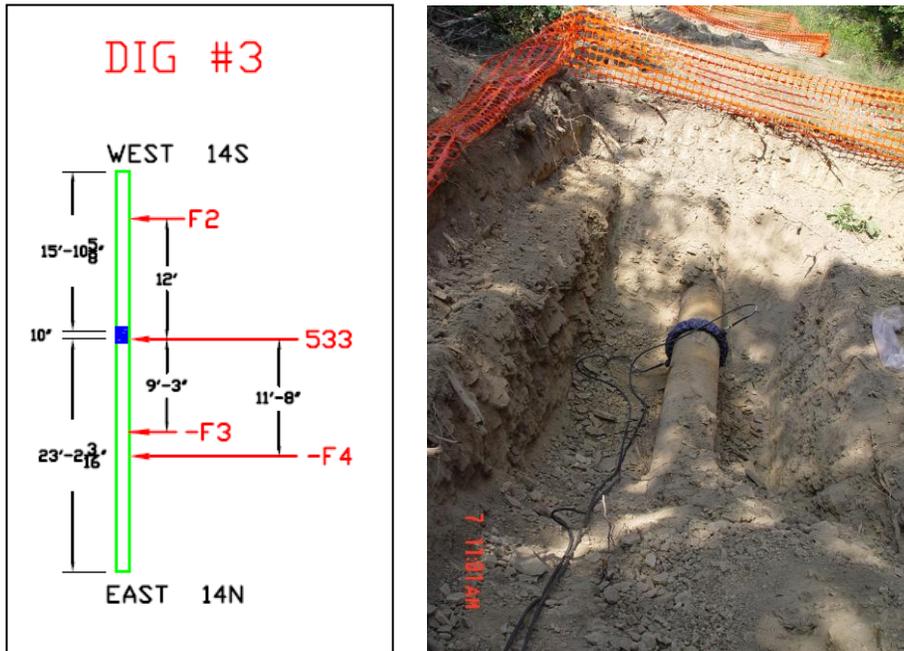
**Figure 119. Equitrans Drawing of Dig Site #3 and picture of site.**

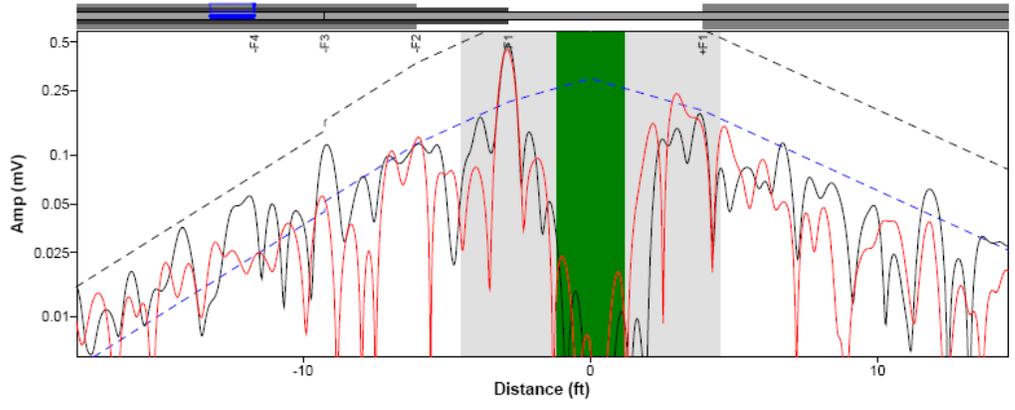
Feature	Location	Length	Class	Notes
+F1	4'0"	~	Earth	
+F2	12'0"	0	Cat 2	Concentrated reflection on the bottom north side of the pipe.
-F1	-3'1"	~	Earth	Initial contact of earth with bottom of pipe
-F2	-6'1"	~	Earth	Entrance of full pipe into the earth
-F3	-9'3"	0	Weld	
-F4	-11'8"	1.5	Cat 2	Area of reflections of no particular circumferential orientation – could be caused by noise of deposits.

Figure 120. Dig Site #3: Pulse-Echo Torsional Scan.

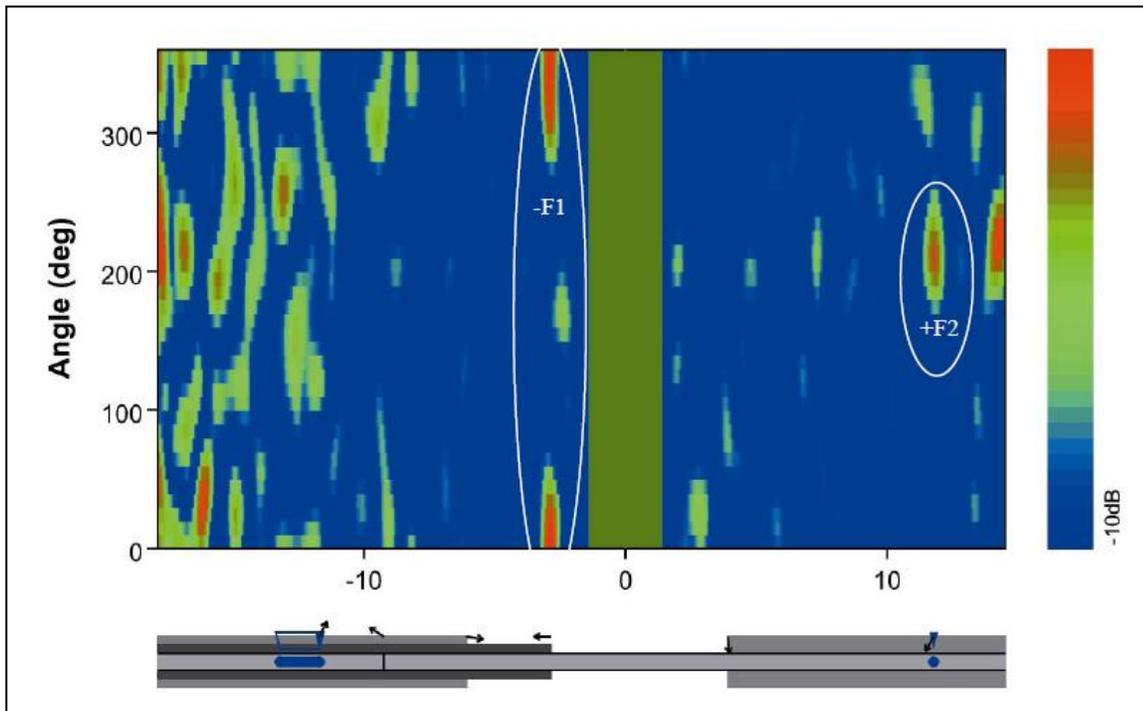
Figure 121. The unrolled pipe display shows that the ground entrance consists primarily of reflections from the top and the bottom of the pipe, which matches the actual geometry. The concentrated nature of the reflection at +12 feet shows up more clearly in this display than in the traditional A-scan display.

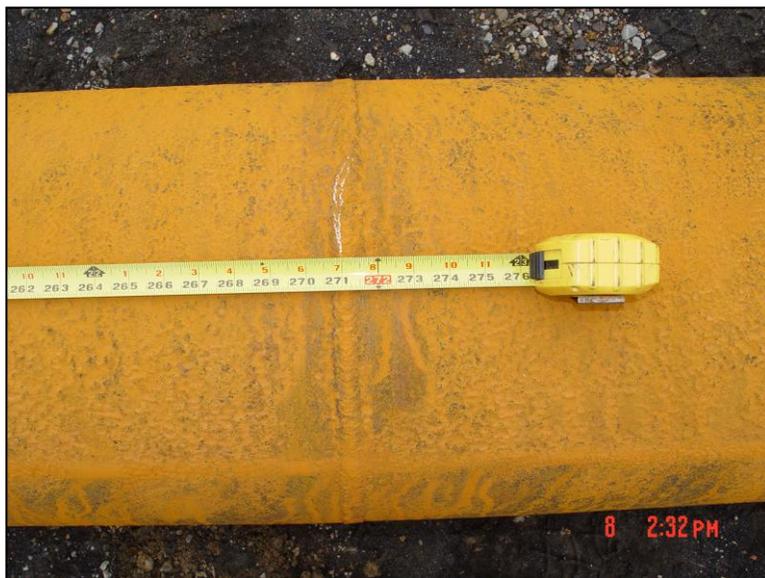
Figure 122. Dig Site #3: typical pipe condition showing a weld.

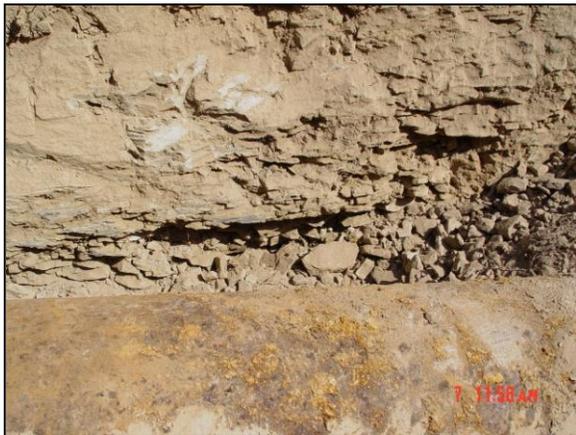
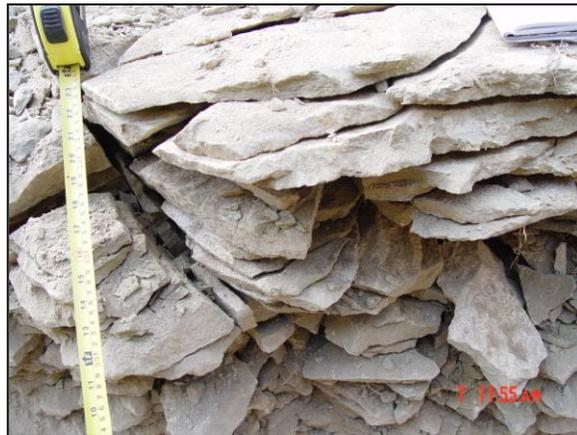
Figure 124. Shale around pipe at dig site #4.

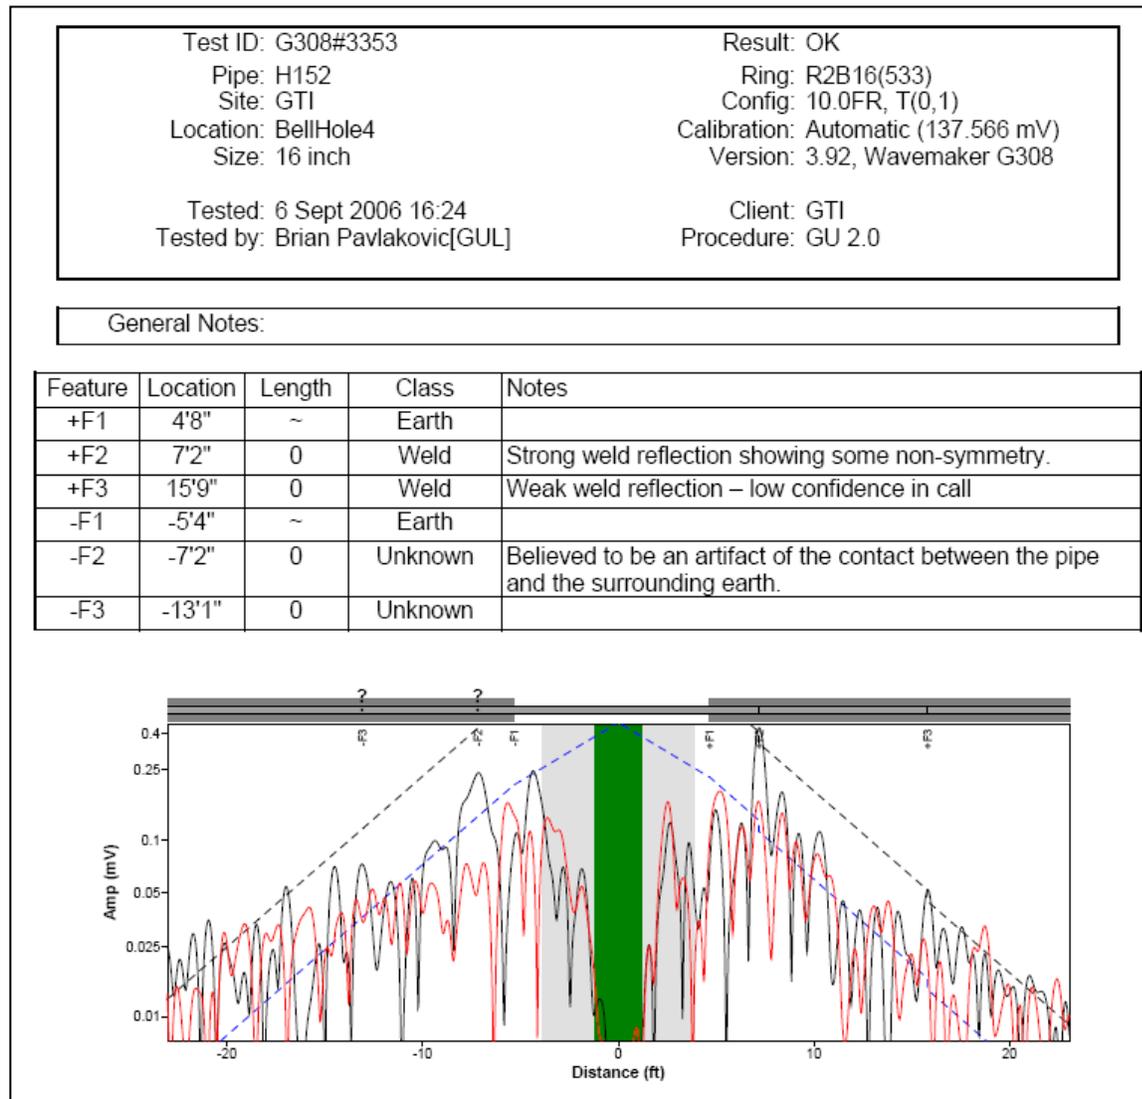
The results from bell hole 4 (on the west end of the inspected region) indicate several areas of symmetric contact, but no areas of major concern. The inspection range was approximately 15 feet in either direction with low confidence in the results.

**Figure 125. Dig Site #4: Pulse-Echo Torsional Scan.**

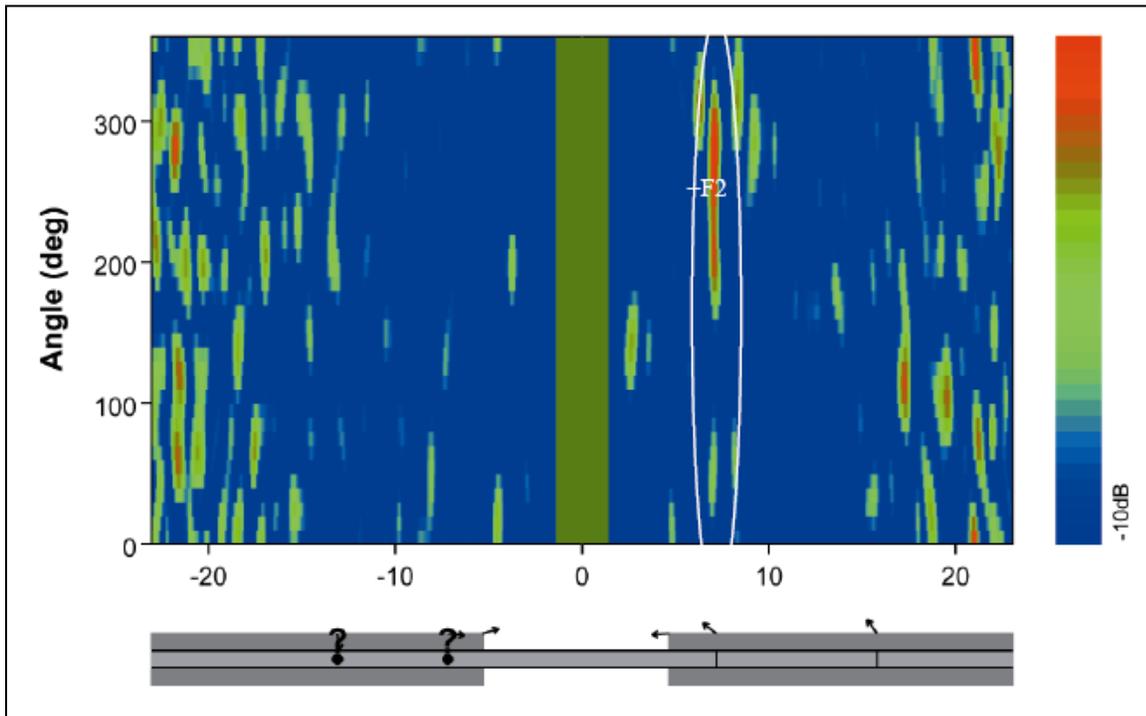
Figure 126. Unrolled pipe display for the Bell Hole 4 (Test G308#3353). +F2.

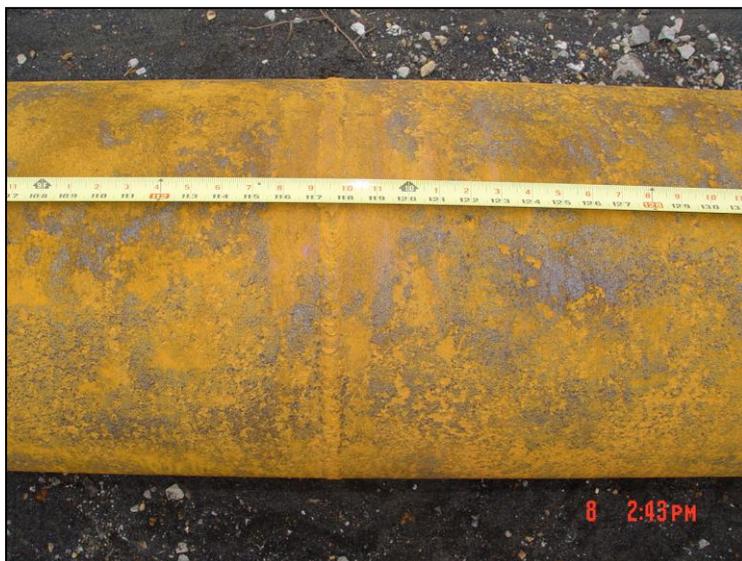
Figure 127. Dig Site #4: typical pipe condition showing a weld.

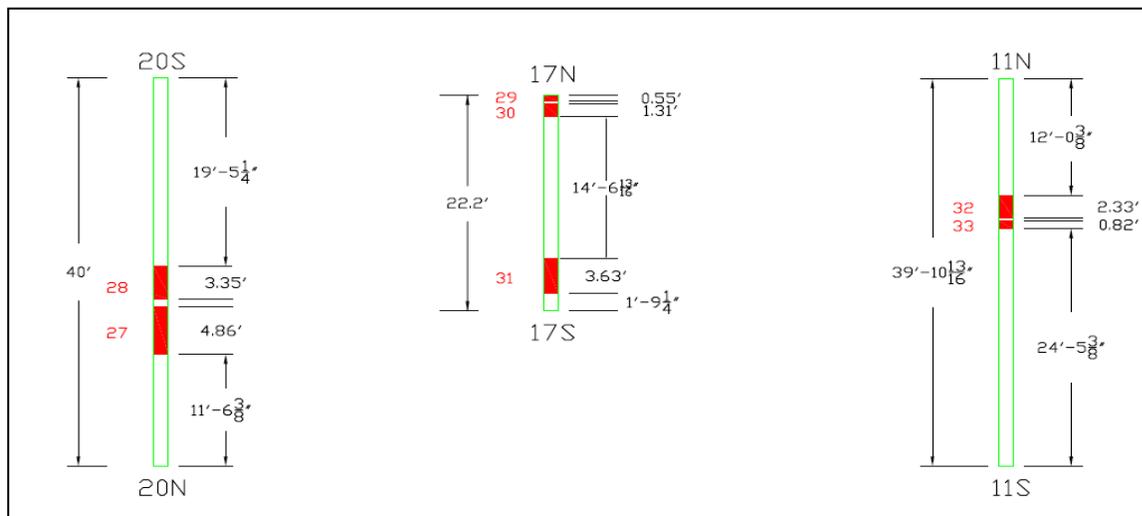
The section of pipeline with coordinates 1873' through 2264' (where GTI study was conducted using alternate inspection method) was considered in "acceptable" condition. Corrosion defects that exceed 50% of pipe wall loss were not revealed. The largest wall loss was predicted within anomaly # 28 (30% to 37%). The inspection did not predict/indicate any defective welds. Upon excavation and visual inspection, no defects were identified in the area of any of the anomalies #27 through #33).

**Figure 128. Transkor-USA, Inc. MTM Indications #27 through #33.**

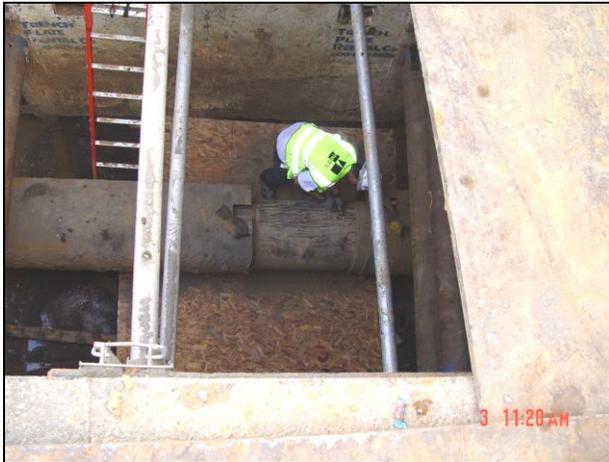
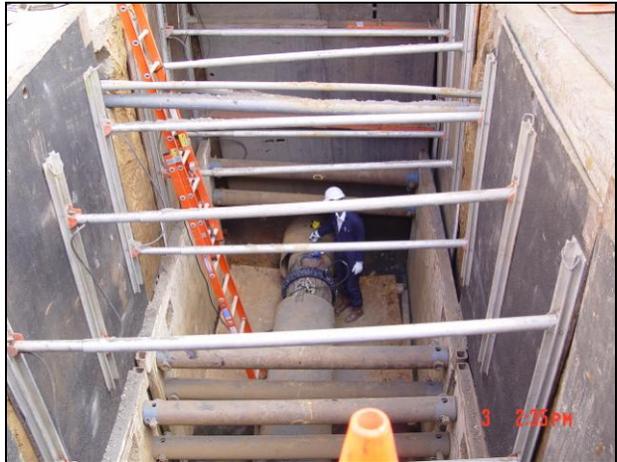
Figure 135. (a & b) Dig site #2 showing pipe emerging from under the freeway at the east end of the dig. The casing with notch can be seen in the right hand image next to the GUL ring.

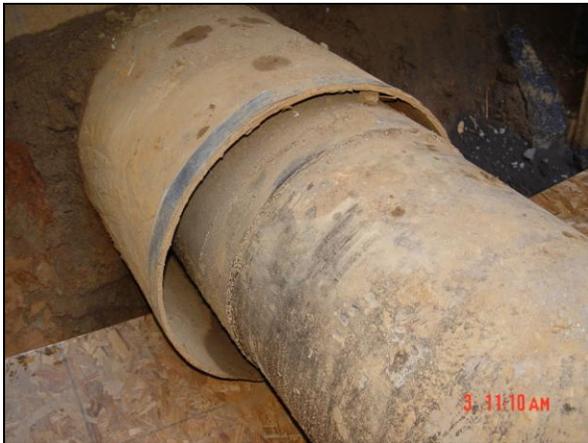
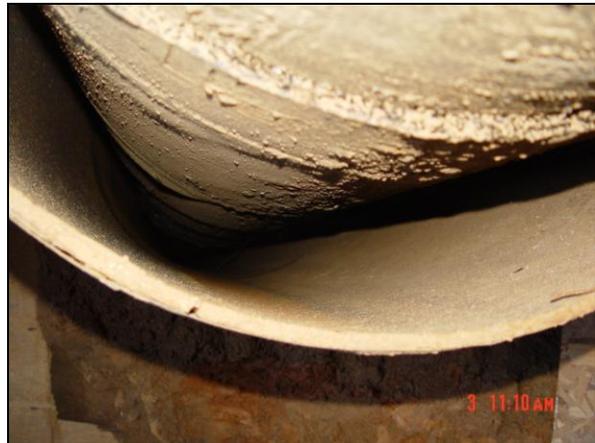
Figure 136. (a & b) Casing in Dig #2 as it emerges from under west side of Hwy 101. No damage to coating/pipe was noted.

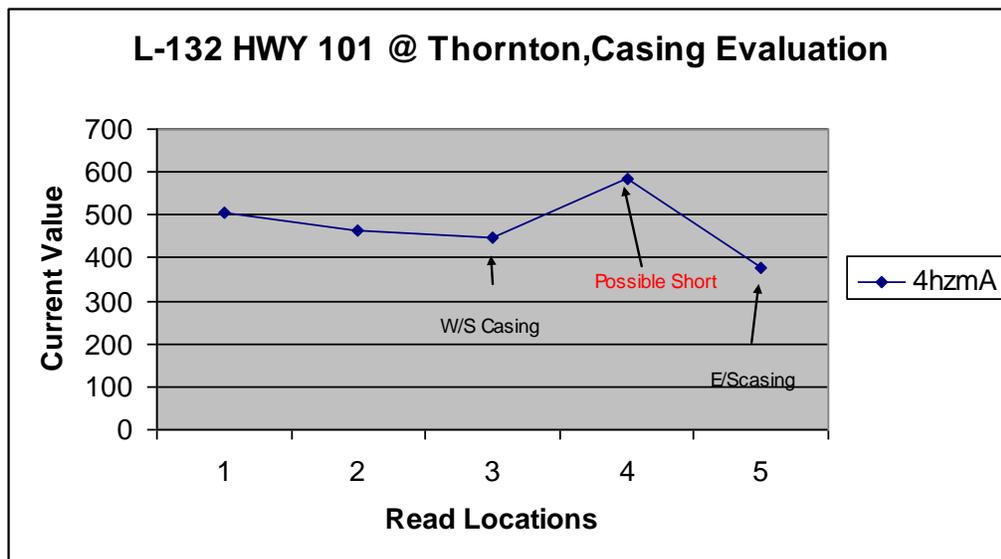
The following inspections were conducted on this cased crossing, Guided Wave, Pipeline Current Mapper (PCM) and PCM/A-frame which indicated a possible short, see Figure 138.

Figure 138. PCM readings either side of the casing under the freeway.

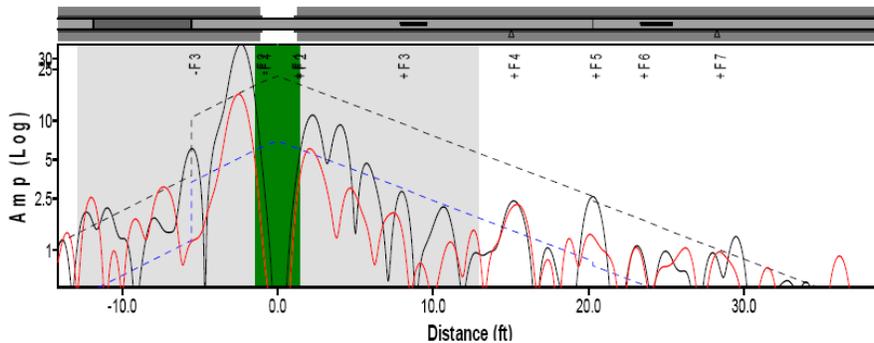
This dig site is approximately 84 feet west of the west edge of the expressway. The result indicates that the pipe enters the soil at -51" and immediately followed by a bend after that in the negative direction. With the desired sensitivity, the range included the pipe beyond 30ft from the transduction ring, however the sensitivity of this data was poor and confidence is limited. Only very large defects could be found with low confidence. For this reason, approximately 30 feet in the positive direction and 15 feet in the negative direction were interpreted. Within this range, several locations of very minor indication were identified but there are no medium and major concerns (see Figure 143 and Figure 144 below).

Figure 144. Location #1 with range limited to approximately +30ft and -10ft from the transducer ring placement.

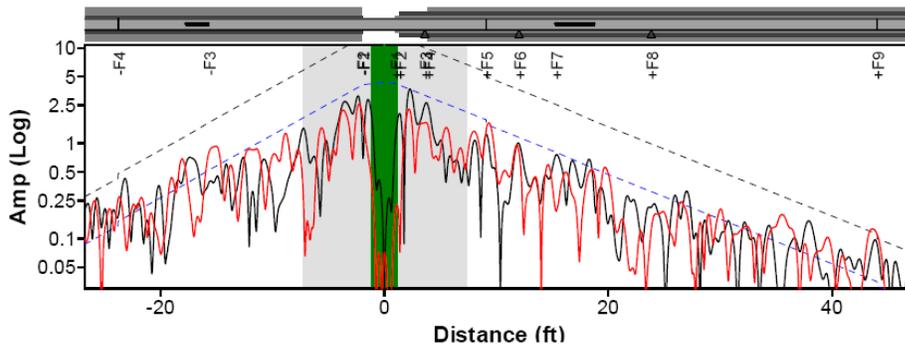
Due to the absorbing effect of the thick coating, the signal amplitudes become highly sensitive to the change of frequency; and therefore not all the corresponding signals of the marked feature locations are shown in the result below. There are two area of concern at approximately +15ft and -17ft as indicated in the result; both locations have been interpreted to be from a change in the pipe condition. Mostly, the interpretation was of little change greater than normal variations to the pipe wall and coating thickness. Although there are some indications beyond 30 feet in the positive direction, the interpretation was done with low confidence due to poor signal quality in this area, see Figure 146.

Feature	Location	Size (mV)	ECL	Class	Notes
-F1	-2'0"	2.61	-	Bitumen	Beginning of the Bitumen wrap
+F1	1'0"	1.94	-	Bitumen	Beginning of the Bitumen wrap
+F2	1'4"	2.26	-	Sleeve	Sleeve slightly off-centre
+F4	4'0"	3.05	-	Earth	Sleeve directly buried in soil
+F3	3'7"	2.66	-	Support	contact with casing pipe
+F5	9'1"	1.25	-	Weld	
+F6	12'0"	1.8	-	Support	asymmetric signal
+F7	15'4"	0.758	10	Cat 3	general wall loss of less than 10% wall loss, or can be due to general manufacturing variation.
+F9	44'0"	0.105	-	Weld	
-F2	-2'0"	3.32	-	Sleeve	Beginning of the sleeve
-F3	-15'8"	0.405	9	Cat 3	general wall loss of less than 10% wall loss

Figure 146. Location #2 with range limited to approximately +45ft and -25ft from the transducer ring placement.

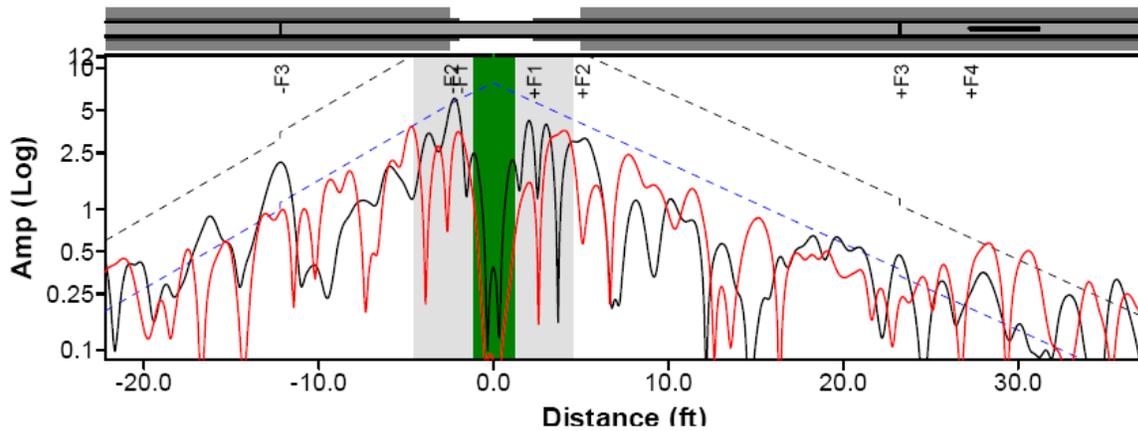
Feature	Location	Size (mV)	ECL	Class	Notes
-F3	-12'2"	2.35	-	Weld	
-F2	-2'6"	25	-	Sleeve	
-F1	-2'0"	25	-	Bitumen	Beginning of the tar coating
+F3	23'3"	0.531	-	Weld	
+F4	27'3"	0.28	14	Cat 3	beyond inspection range and therefore has low confidence
+F2	5'0"	7.37	-	Earth	directly earth buried
+F1	2'3"	37.3	-	Bitumen	Beginning of the tar coating

Figure 147. Dig Location #3 with range limited to approximately +35ft and -20ft from the transducer ring placement.

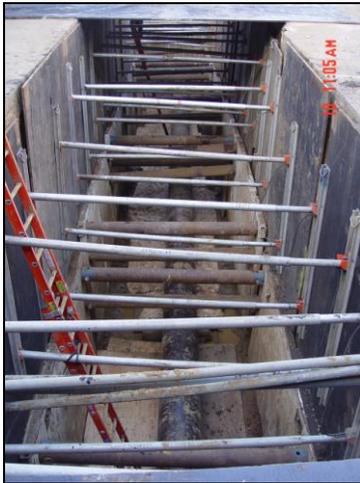
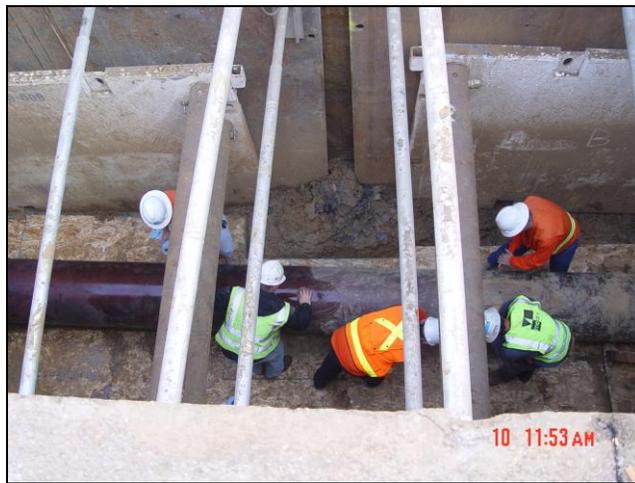
Figure 148. Casing removed, coating removed, and pipe being washed for visual inspection.

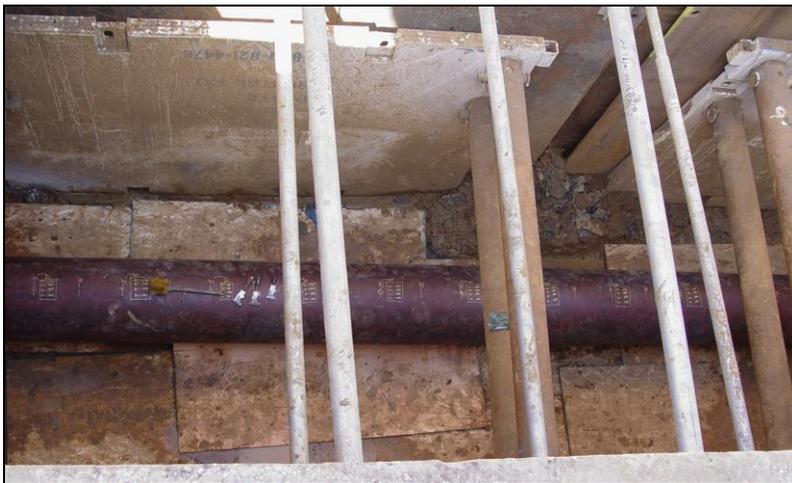
Figure 149. Pipe ready for sand blasting before second inspection.

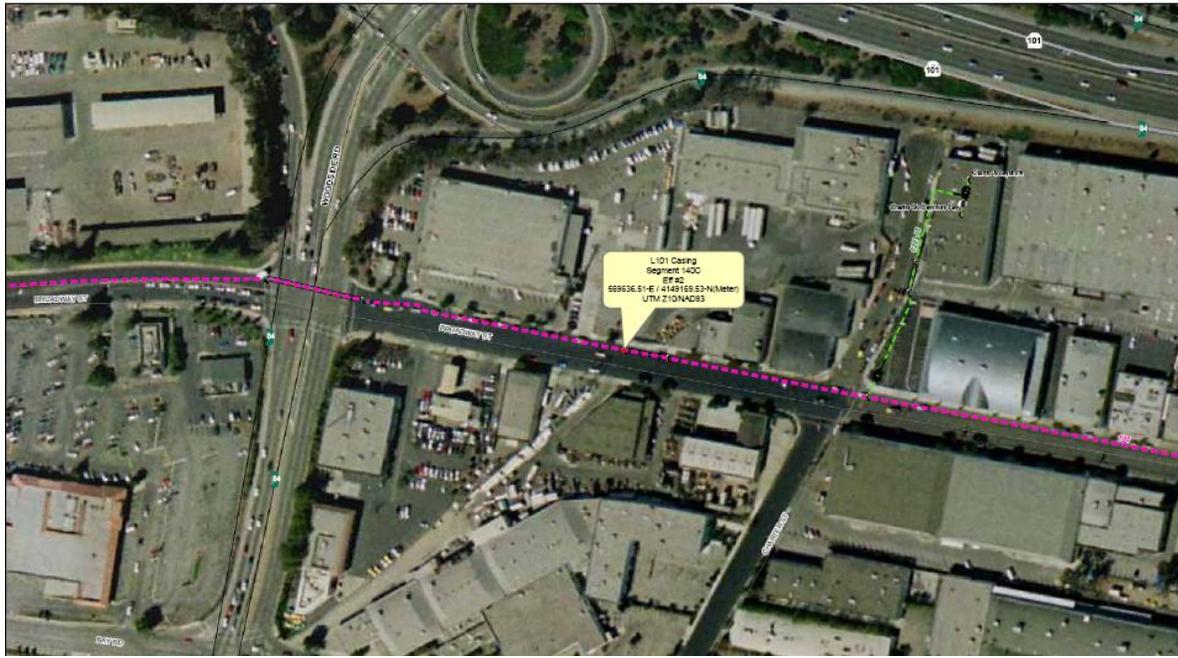
Figure 156. Line L101 – 140 either side of an abandoned railway spur.

Line L101-140C – The pipe line segment has a 76 foot casing under abandoned and removed rail line: The line was installed in 1985, and is 24.00" diameter, coated with extruded Polyken PE backed mastic tape wrap. The 30" diameter casing is not coated and the casing is not filled with a corrosion mitigation material, and is vented. The only possible path for water intrusion is through the end seals.

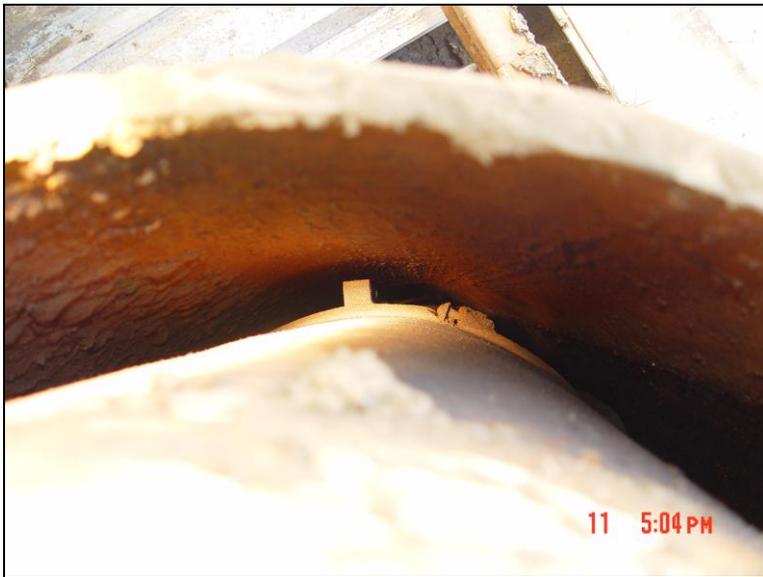
Figure 160. Casing at 12 o'clock showing space band and spacer.

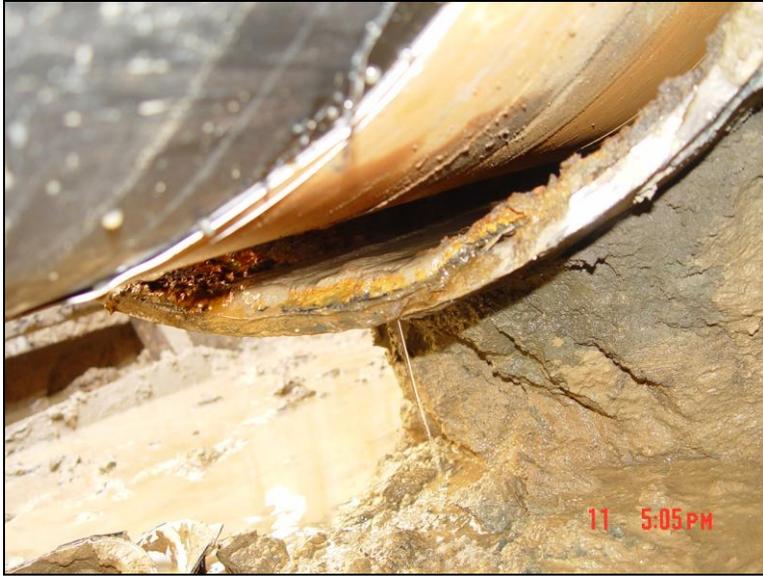
Figure 161. Casing edge at 6 o'clock showing some calcareous like deposit on the casing.

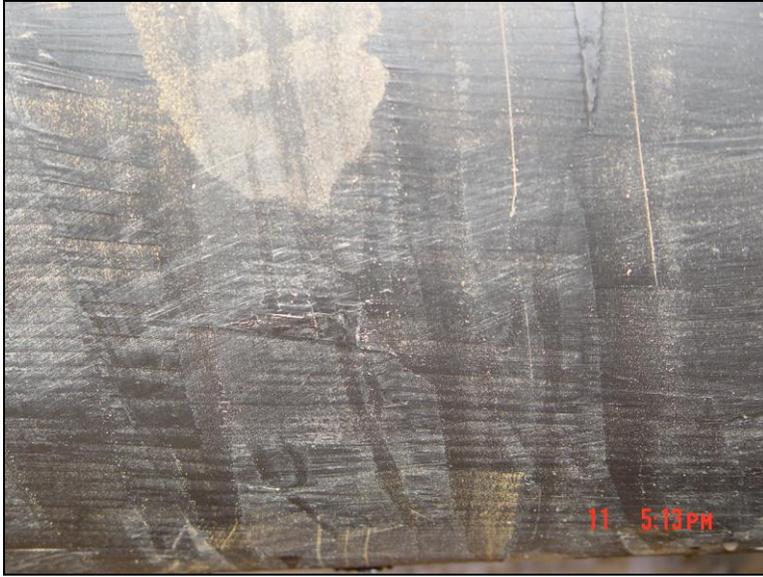
Figure 165. Pipe showing well adhering coating before final cleaning.
